## Memo

To:	Ms. Bethany Leavitt, Director of Public Works
From:	Daniel J. Bannon, P.E. and Darren Clark, P.E.
C:	Chris Wharff, Harbormaster
Date:	March 4, 2024
Re:	Bar Harbor Town Pier Post-Storm Inspection Test Pit Investigation Bar Harbor, ME GEI Project No. 2400335

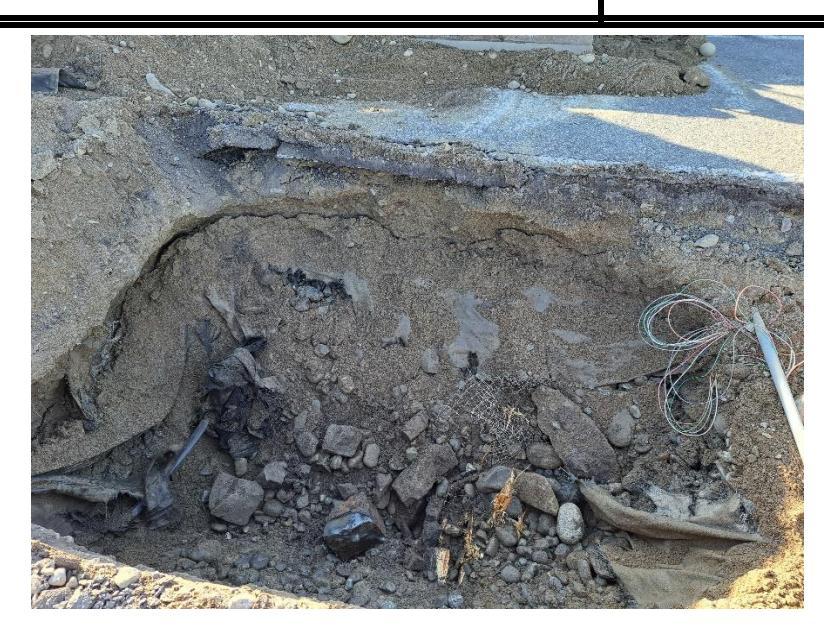
— 3 — 3			2.5-6': SILTY GRAVEL WITH SAND (GM): ~55% gravel up to 2.5", ~30% medium-coarse sand, ~15% silt, brown, wet, FILL. Many smooth, round cobbles. Timber/creosote odor in air. Encountered layer of geotextile at 3.0'				
4 5	G-2 @ 1430	2.5 - 6	Encountered layer of geogrid at 5.0'				
			Encountered two	12"x12" timbers at 6.0'

Photo 1: TP-1 excavation

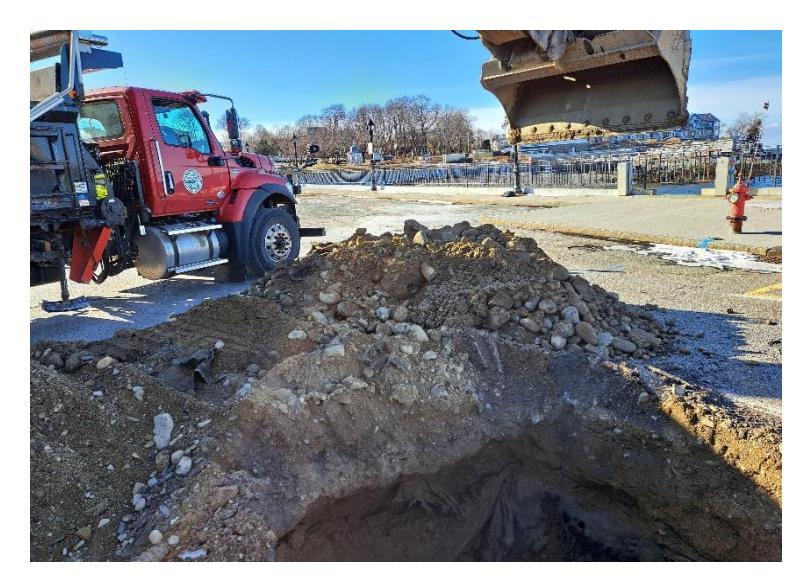
- 7			Bottom of test pit at ~6 ft. Refusal on large timbers. Test pit spoil pile ~40% cobbles and boulders, rounded-subrounded, up to 1.5' in diameter. Test pit backfilled with excavated soil tamped down with excavator bucket in lifts.

Photo 2: TP-1 excavated material

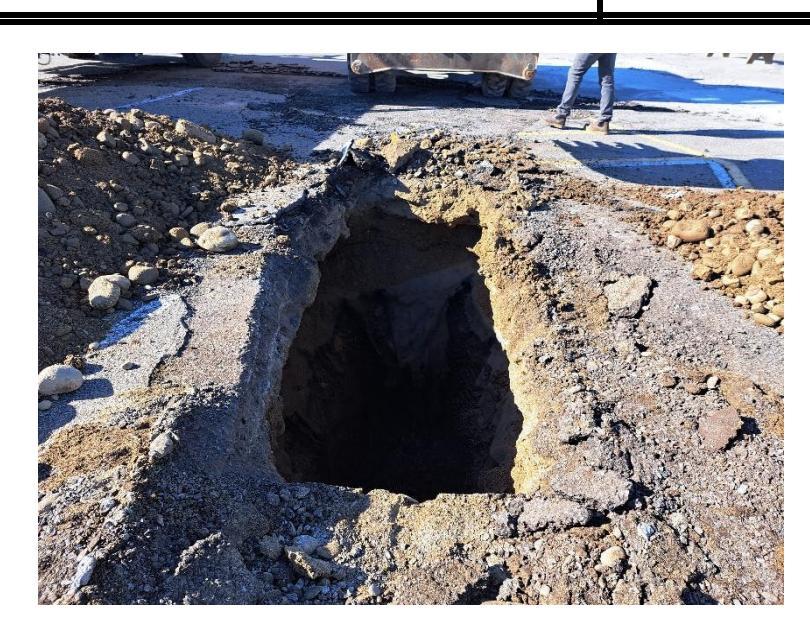
Photo 1: TP-2 excavation

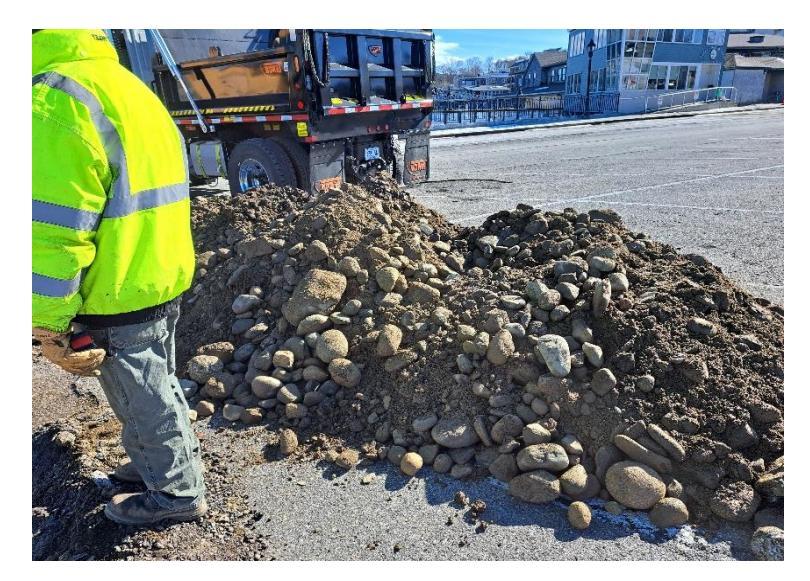
— 4 —			Encountered la	yer of geogrid at 4.83'
- 5 - 6 - 7 - 7	G-2 @ 1250	5 - 9	5-9': SILTY GRAVEL WITH SAND (GM) sand, ~20% silt, brown, wet, FILL. Trace odor. Many large, r	: ~50% gravel up to 2", ~30% medium-coarse coal fragments, trace wood fragments, organic ounded, smooth cobbles.
<b>-</b> 9			Bottom of test pit at ~9 ft. Test pit spoil p in diameter. Test pit backfilled with exca	ile ~40% cobbles, rounded-subrounded, up to 1' vated soil tamped down with excavator bucket in lifts.
Notes: 1 - No wate 2 - Test pit b 3 - Test pit v	r table encounte backfilled with e was also partial	ered excavated soil ly backfilled v	upon completion vith crushed gravel	Pit Dimensions (ft) Length <u>11</u> Width <u>5</u> Depth 9

Photo 2: TP-2 excavated material

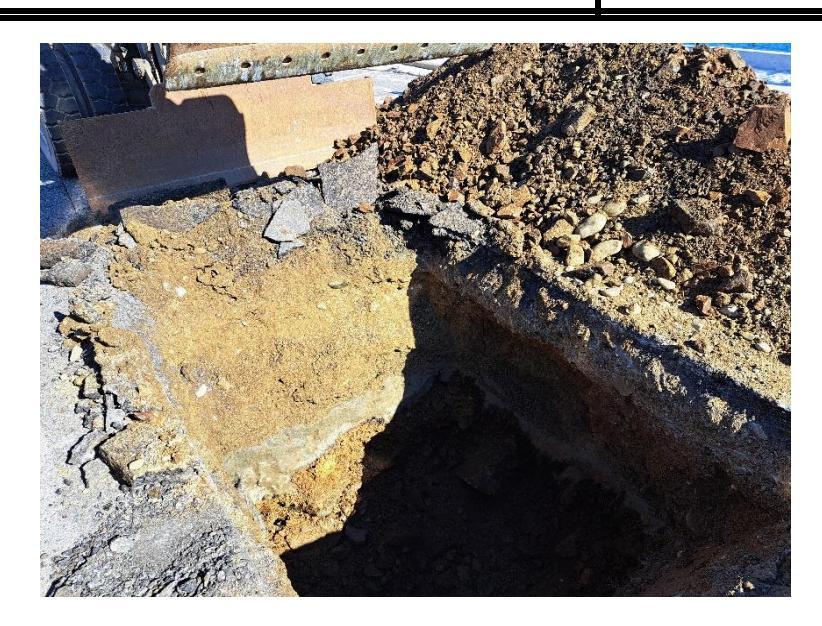
Photo 1: TP-3 excavation

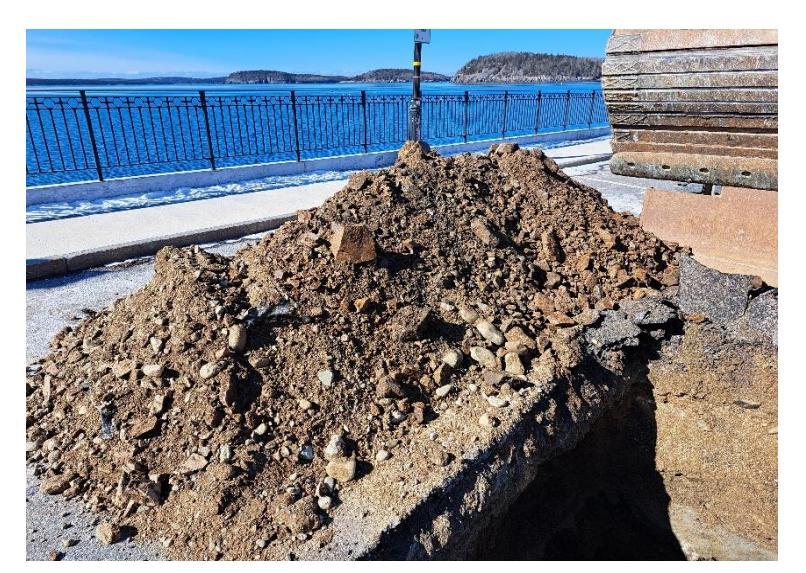
3 4 5 6 7	G-2 @ 1120	3 - 7	3-7': WIDELY GRADED GRAVEL WITH 2.5", ~40% medium-coarse sand, ~10% f bedrock in this layer ~50%	SILT AND SAND (GW-GM): ~50% gravel up to ines, brown, wet, FILL. Many rocks and crushed of weight or more (very angular).		
8			cobbles and boulders, angular, 6"-28" i soil tamped down wi	n diameter. Test pit backfilled with excavated th excavator bucket in lifts.		
<u>Notes</u> : 1 - No water 2 - Test pit k 3 - Test pit v	r table encounte backfilled with e vas also partial	ered excavated soil ly backfilled w	upon completion vith crushed gravel	Pit Dimensions (ft) Length 10 Width 6 Depth 7

Photo 2: TP-3 excavated material

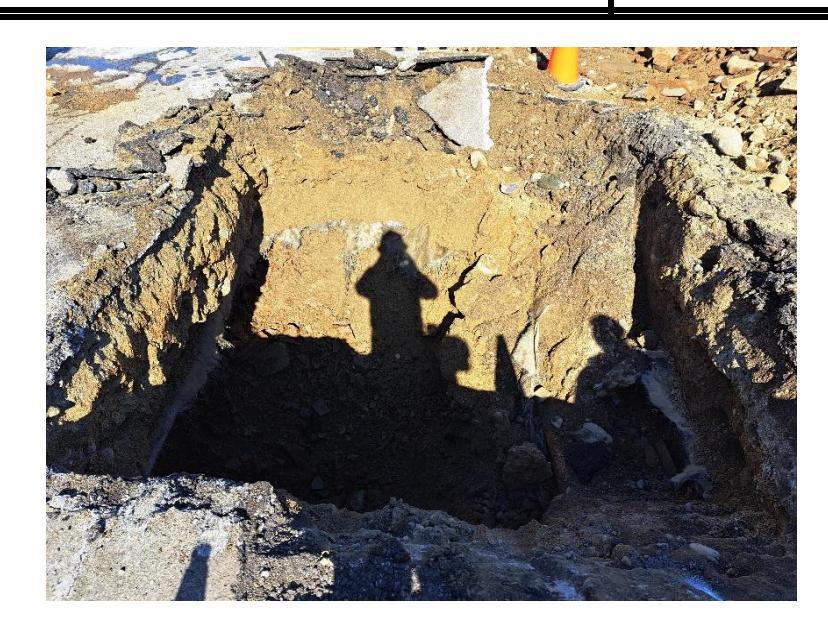
Photo 1: TP-4 excavation

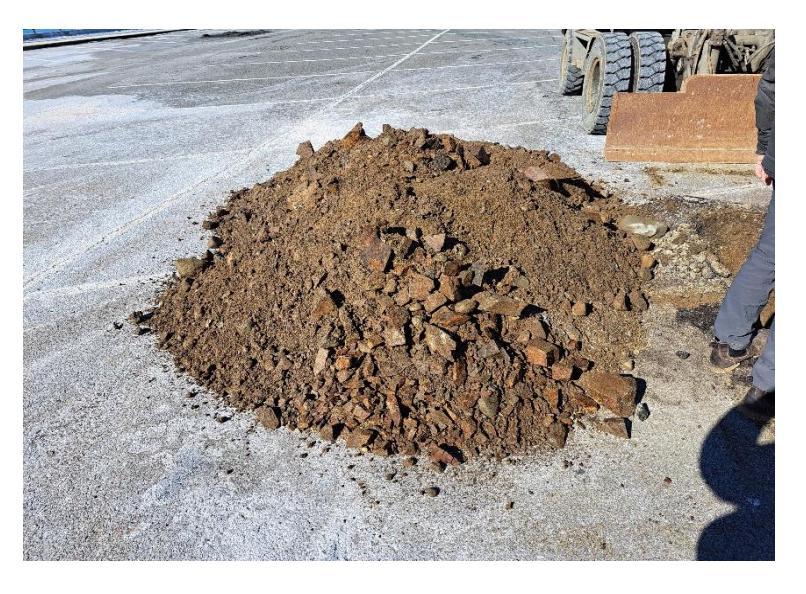
- 6 - 7 - 8			Bottom of test pit at ~8 ft. Test pit spo subangular, up to 2.5' in diameter. Test with excava	oil pile ~50% cobbles and boulders, angular- pit backfilled with excavated soil tamped down ator bucket in lifts.				
Notes: 1 - No water 2 - Test pit k 3 - Test pit v	table encounte backfilled with e vas also partial	ered excavated soil ly backfilled w	upon completion <i>i</i> th crushed gravel	Pit Dimensions (ft) Length 11.5 Width 9 Depth 8

Photo 2: TP-4 excavated material
