## Memo

To:	Ms. Bethany Leavitt, Director of Public Works
From:	Daniel J. Bannon, P.E. and Darren Clark, P.E.
C:	Chris Wharff, Harbormaster
Date:	March 4, 2024
Re:	Bar Harbor Town Pier Post-Storm Inspection Test Pit Investigation Bar Harbor, ME GEI Project No. 2400335

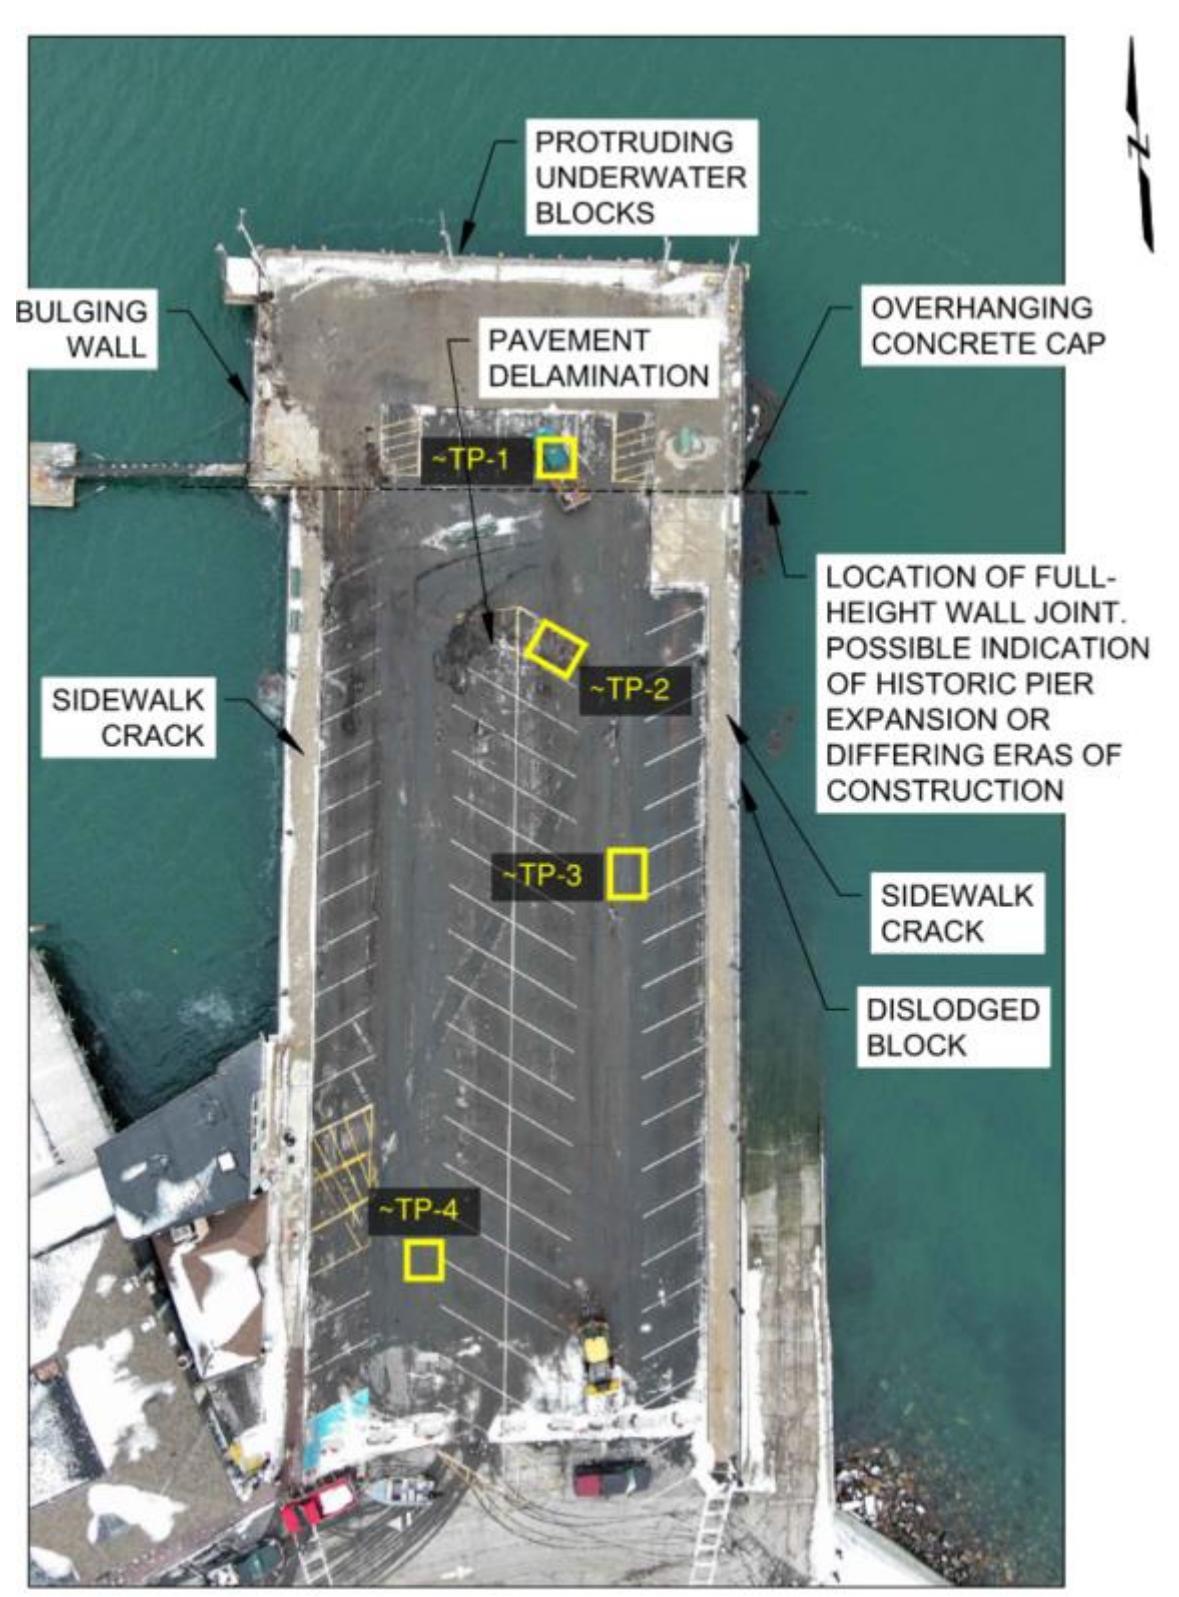
Fig. 1 – Test Pit Locations

GEI Consultants, Inc. observed four (4) test pits at the Town Pier in Bar Harbor, ME on February 21, 2024. The test pits were excavated by contractor KJ Dugas at the approximate locations denoted as TP-1 through TP-4 on Fig. 1 (Attachment 1).
